WARTIME REPORT

COMPRESSION TESTS OF SIX CURVED PAPER-BASE PLASTIC

PANELS WITH OUTWARD-ACTING NORMAL PRESSURE

By Evan H. Schuette, Norman Rafel,
and Charles V. Dobrowski

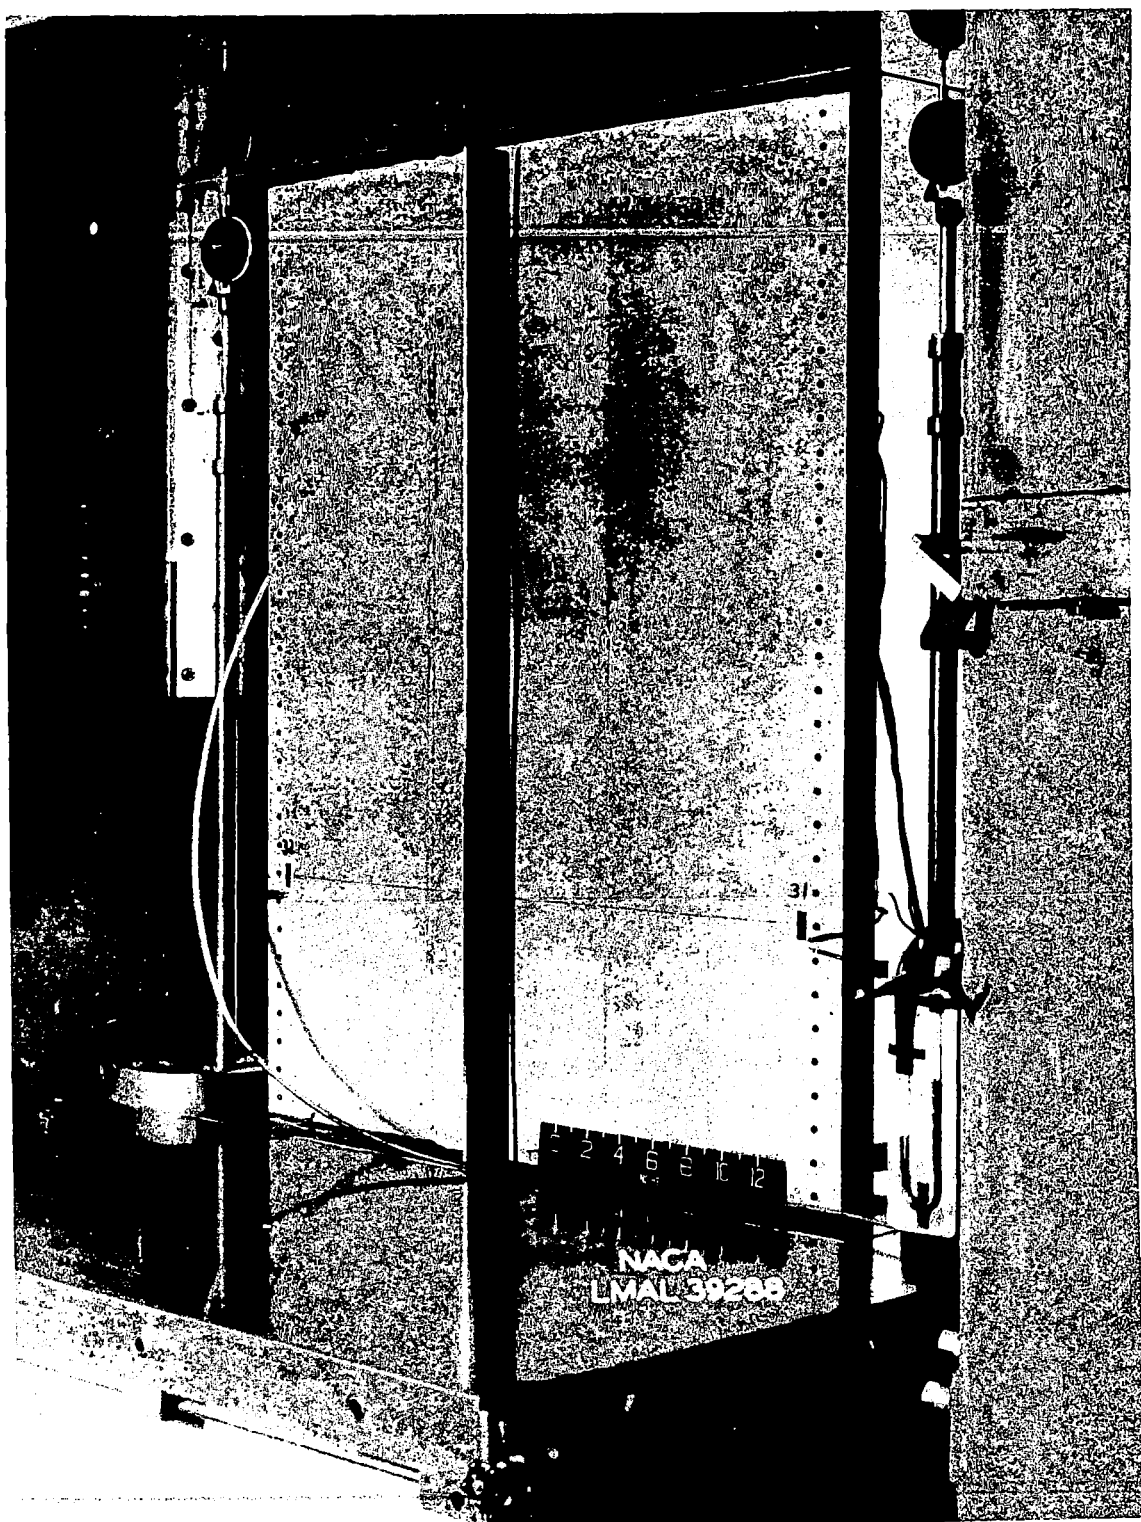
In all the tests, the introduction of air pressure caused a quilting of the skin between ribs and stiffeners, as shown in figure 4, and produced depressions at the stiffeners. The quilting and resultant depressions increased in severity as the axial load was applied and increased.

Figure 4.- Test panel under load, showing typical quilting of skin between ribs. Note shadow of straight edge.

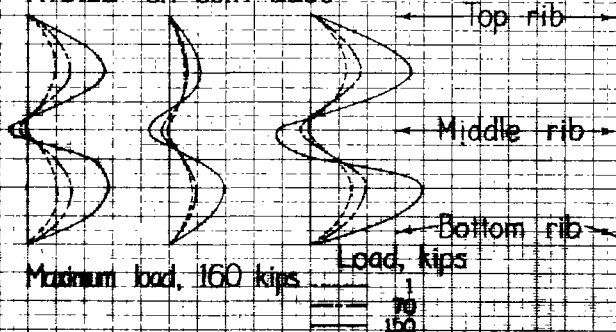
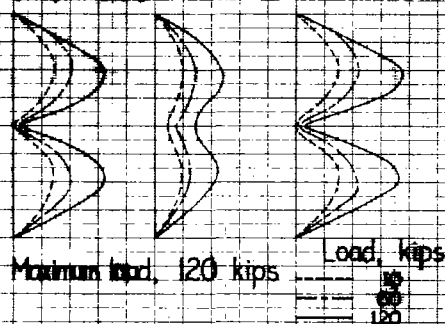
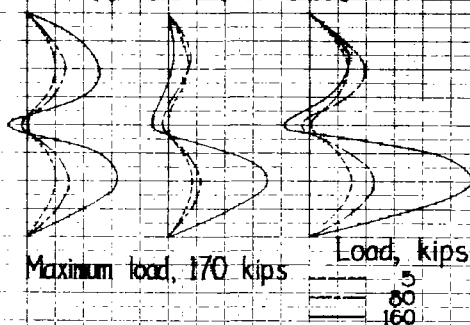
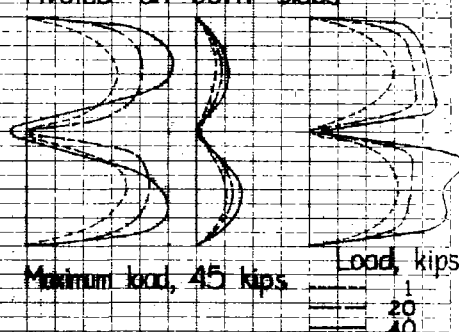
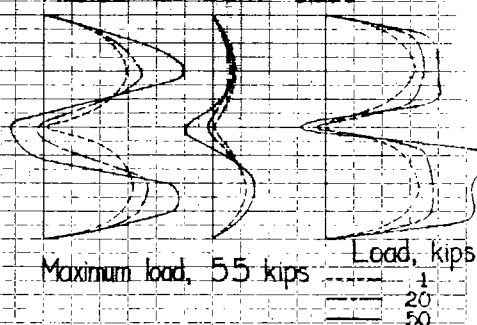
Figure 5.-Lateral-deflection plots for test panels.

The quilting effect is evident from the lateral-deflection plots of figure 5. These plots also show clearly the effect of the clip angle between the rib and stiffener in restraining the lateral movement of the stiffener where it crosses the rib (compare panel no. 2 with panels no. 1 and 3).

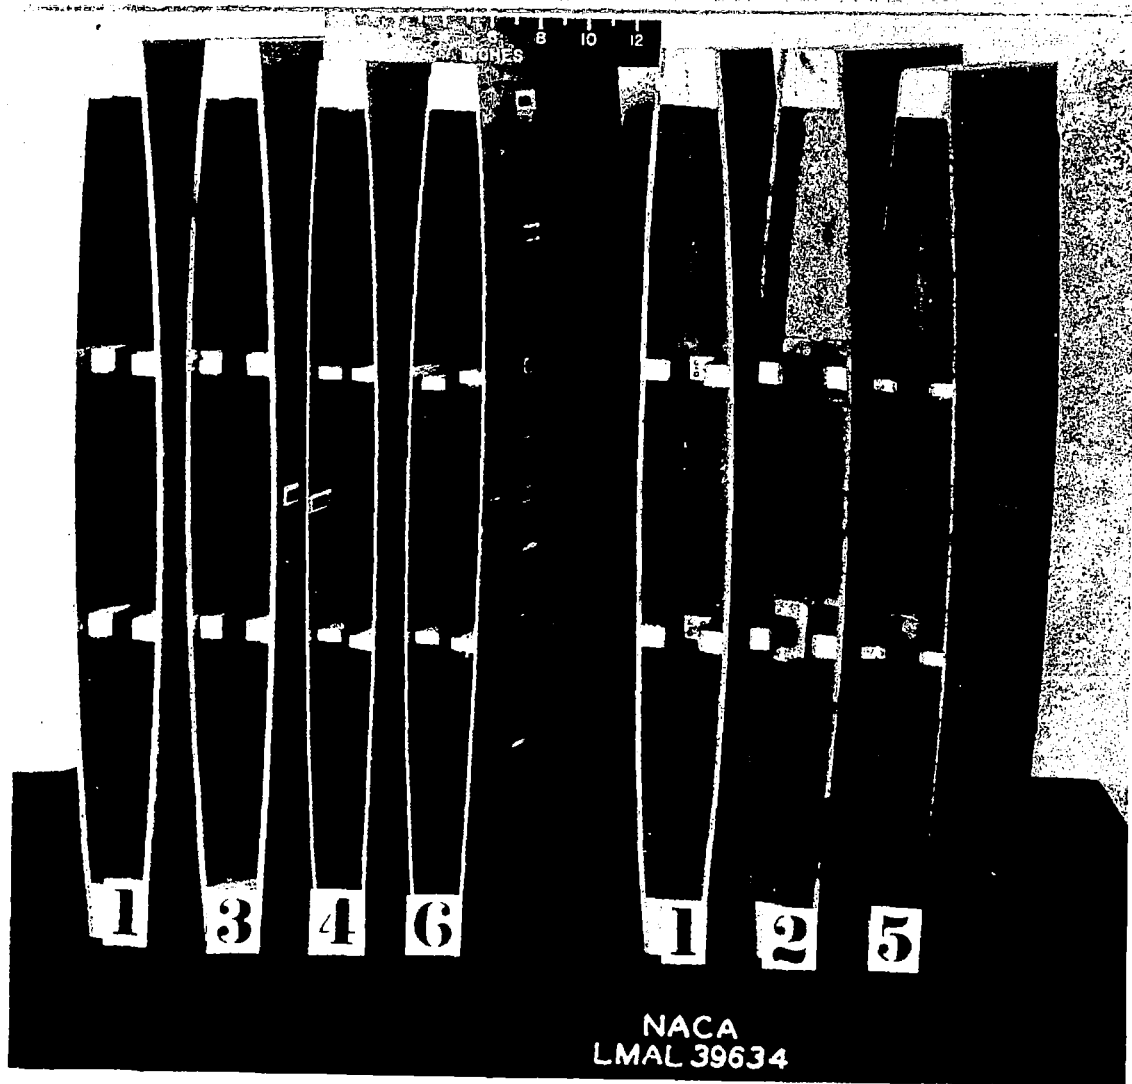
In every test failure occurred by separation of the skin, either from the rib or from the stiffeners. These separations are shown in figure 6, and the loads and corresponding average stresses at which they occurred are listed in table 2. Because the failure was a separation rather than a failure of the material, the average stresses listed in table 2 are much lower than the maximum compressive stresses for any of the materials comprising the panels. For example, panel no. 3, which

Separation from the rib occurred in only one specimen where the clip angles were used to attach the stiffeners to the rib (panel no. 1), and in this case separation from the stiffeners also occurred. Panels no. 2 and 5 did not have clip angles, and both these panels failed by separation of the skin from the rib, with no accompanying separation of skin and stiffeners. An examination of these two panels indicated that the failure was the result of a tearing action, which presumably began at the point where the rib is interrupted by the stiffener. In the other panels, the clip angle evidently served to tie the two skins together and thus inhibited this tearing action and delayed the separation of the skin from the rib, resulting in a higher ultimate load.

Figure 6.- Sections of test panels after failure, showing separation of skin from stiffeners and rib. (See table 2.)

The addition of clip angles to attach the stiffeners to the rib served to delay separation of the skin from the rib, and thus enabled the panels to carry a higher ultimate load.
